HO-15

**National Register of Historic Places
Inventory—Nomination Form**

historic Glenelg Manor
and/or common Glenelg Country School

Glenelg Manor
Howard County

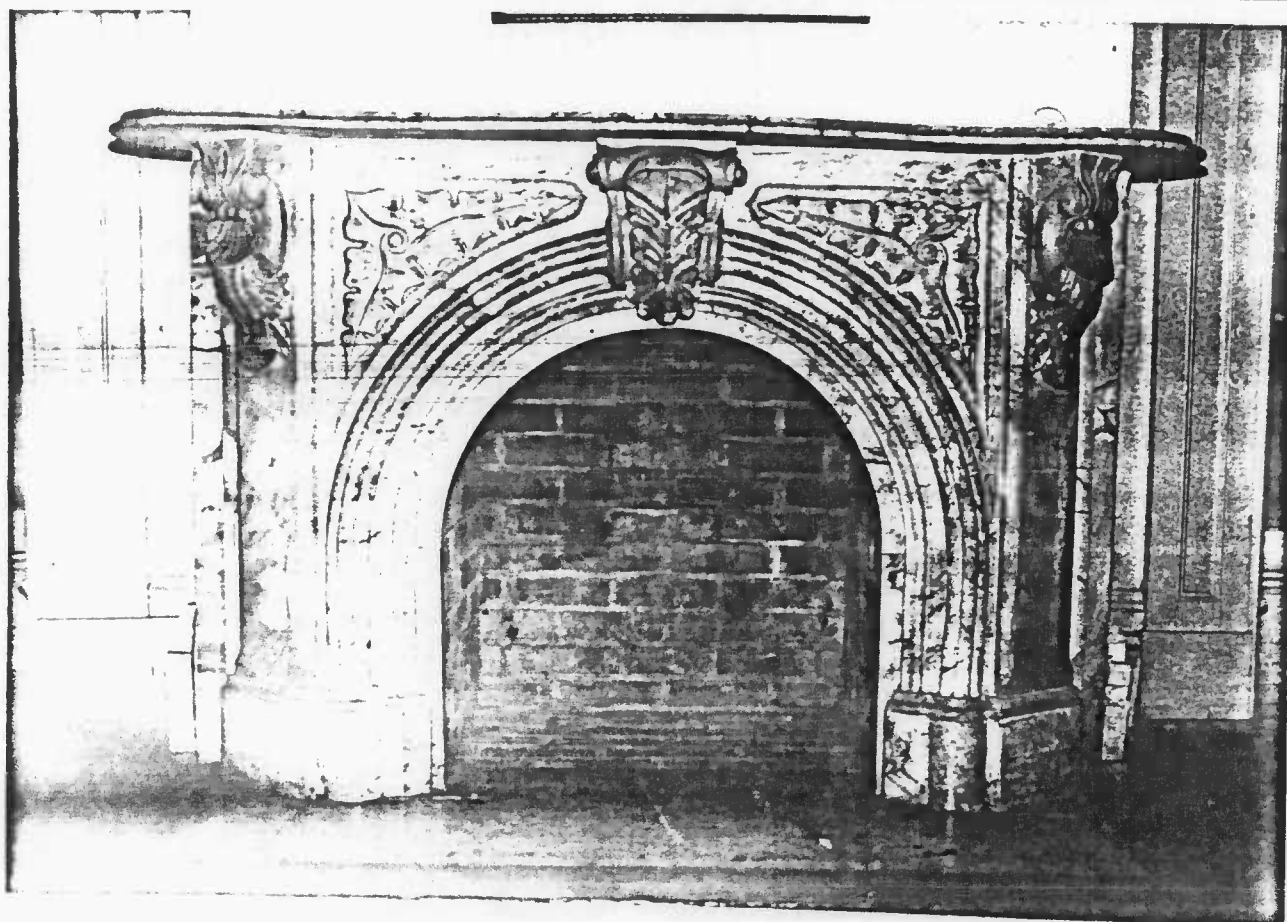
Glenelg Manor HO-15
Howard County, Maryland
Mark R. Edwards, February, 1980
Neg. located at MHT
Rear (southwest) parlor fireplace
(yellow marble), closest to hall
doorway.
2 of 24

In the rear parlor, identical yellow marble (Brescia) mantels adorn the two fireplaces on the south wall of the house located between windows. These mantels are characterized by arched openings, complex molded surrounds, and a carved leaf motif in the keystone with the two end brackets supporting a curved mantel shelf. The spandrels are also decorated with a triangular leaf motif. At the east end of this rear parlor are two doorways, symmetrically placed and identically detailed, but the northernmost of these leads only to a closet. The southernmost of the two windows at the west end of this room has been blocked up to accomodate bookshelves.

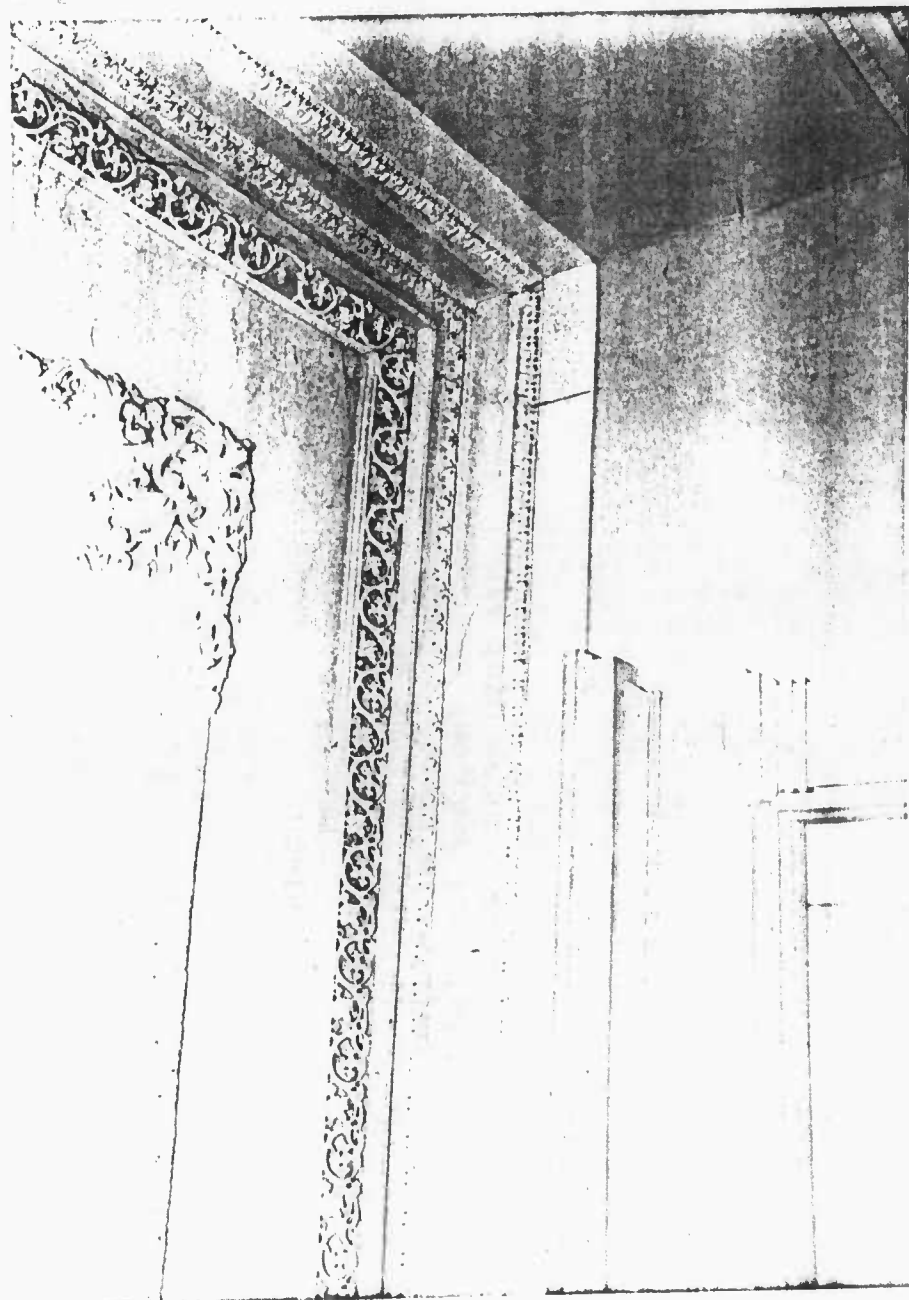
Glenelg Manor HO-15
Howard County, Maryland
Mark R. Edwards, February, 1980
Neg. located at MHT
Rear (SW) parlor detail of ceiling
plasterwork and doorcase for sliding
double doors into front parlor.
10 of 24

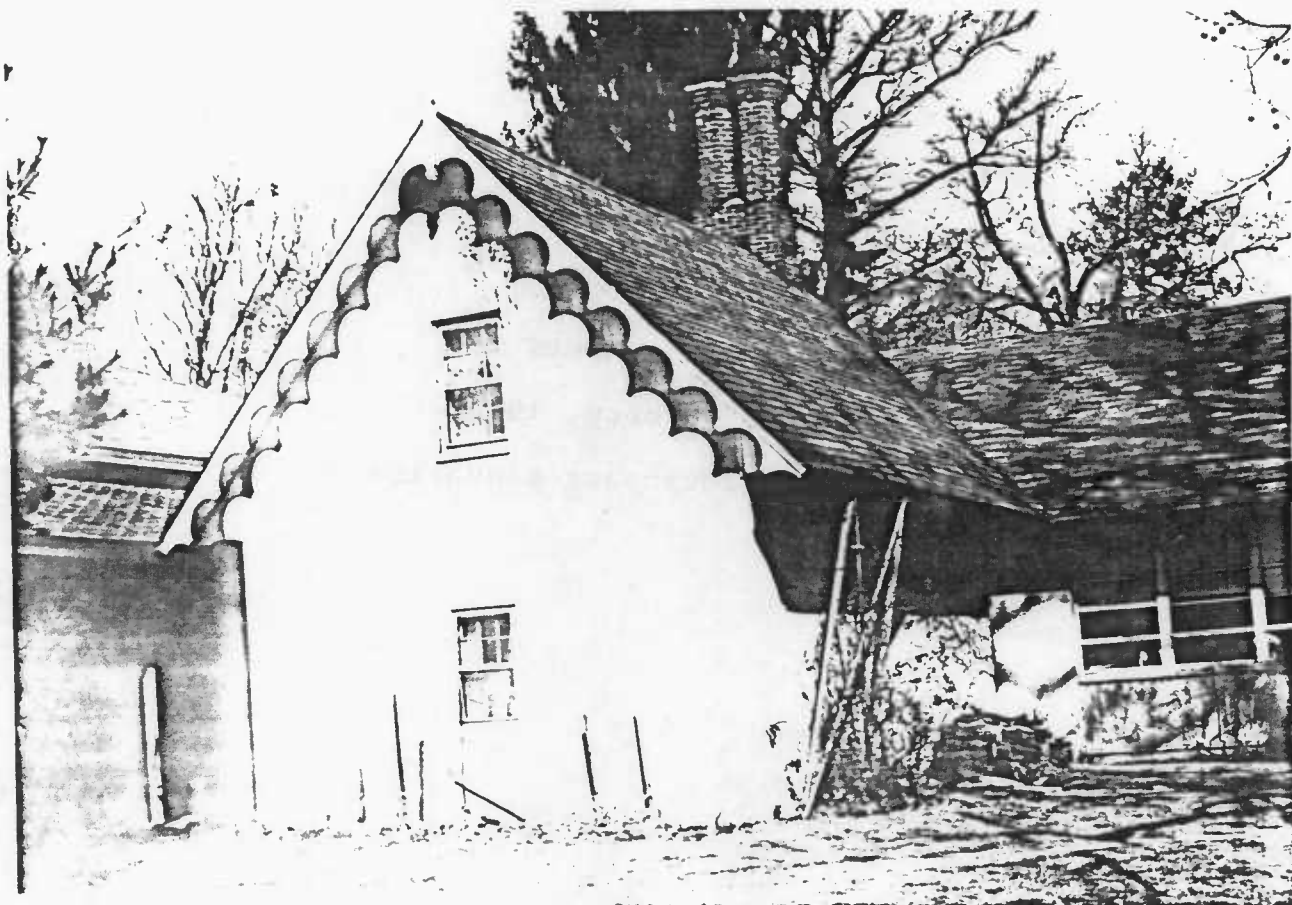
Glenelg Manor HO-15
Howard County, Maryland
Mark R. Edwards, February, 1980
Neg. located at MHT
Oneroom cottage, southeast elevation
19 of 24

The grounds which surround Glenelg, fifty acres of extensively landscaped and terraced land, are populated by a number of interesting outbuildings--including a small cottage with one-room plan located southwest of the main block and now surrounded on two sides by the school's western additions. The gable-roofed cottage is stone, sheathed in scored ashlar stucco with paired chimney pots in the north end, and a wooden boxed cornice with deep overhang. The south gable end features a verge board with semicircular cut-outs and two 6/6 double hung windows that are replacements, the larger one lighting the attic. The east facade contains modern door, its entrance hood removed, flanked to the north by a single window. The west facade contains two windows, with 6/6 replacement sash but retaining beaded wooden surrounds.

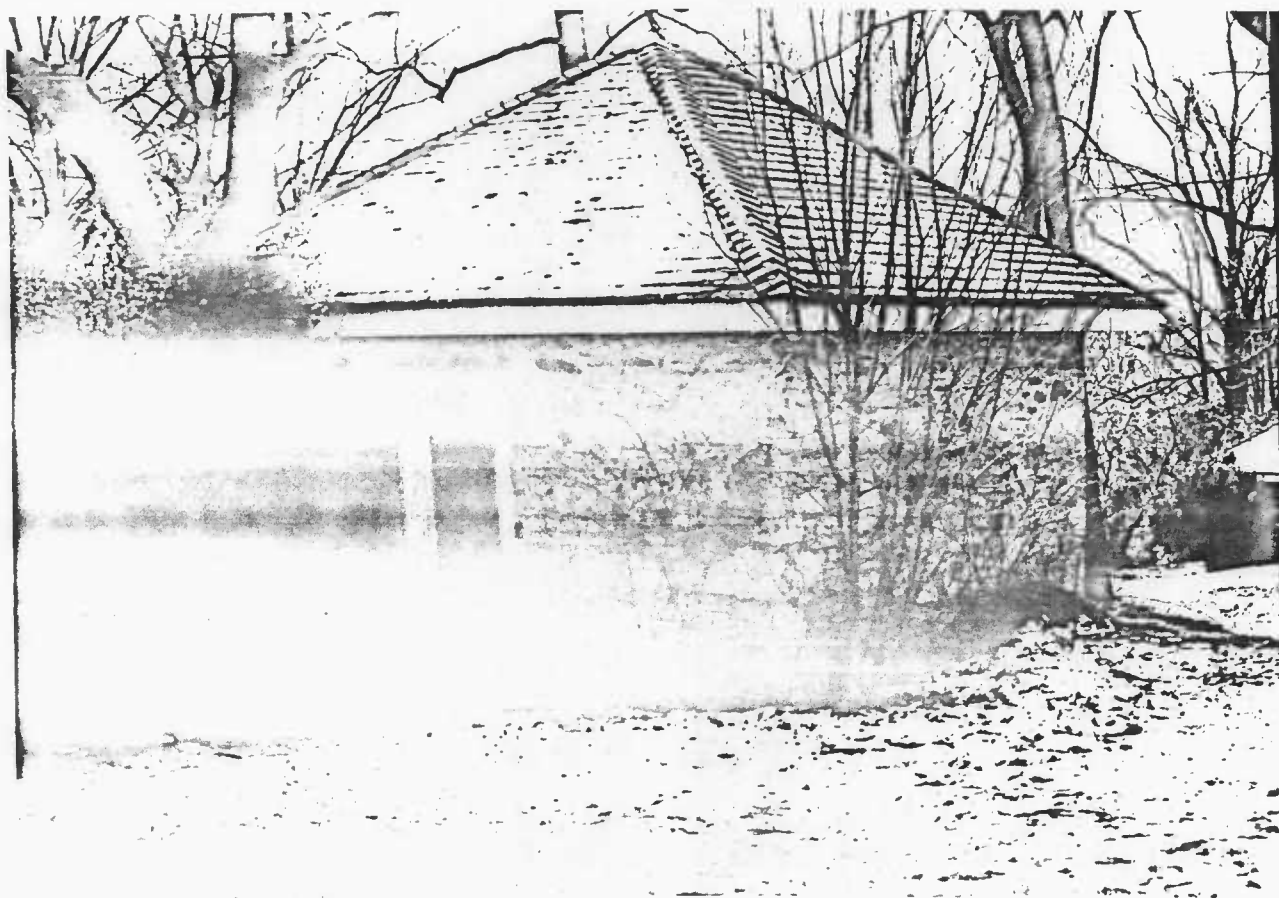
Glenelg Manor HO-15
Howard County, Maryland
Mark R. Edwards, February, 1980
Neg located at MHT
Smokehouse, northwest corner
20 of 24

stone with a wooden boxed cornice which is beaded and creates a substantial overhang on all four sides. An original six-panel door on its south side features two immense strap hinges and is surmounted by a larger granite lintel. Slit windows, formed by the placement of canted stones, allow for ventilation and occur on each of the three other sides. A shingled hip roof shelters the structure.

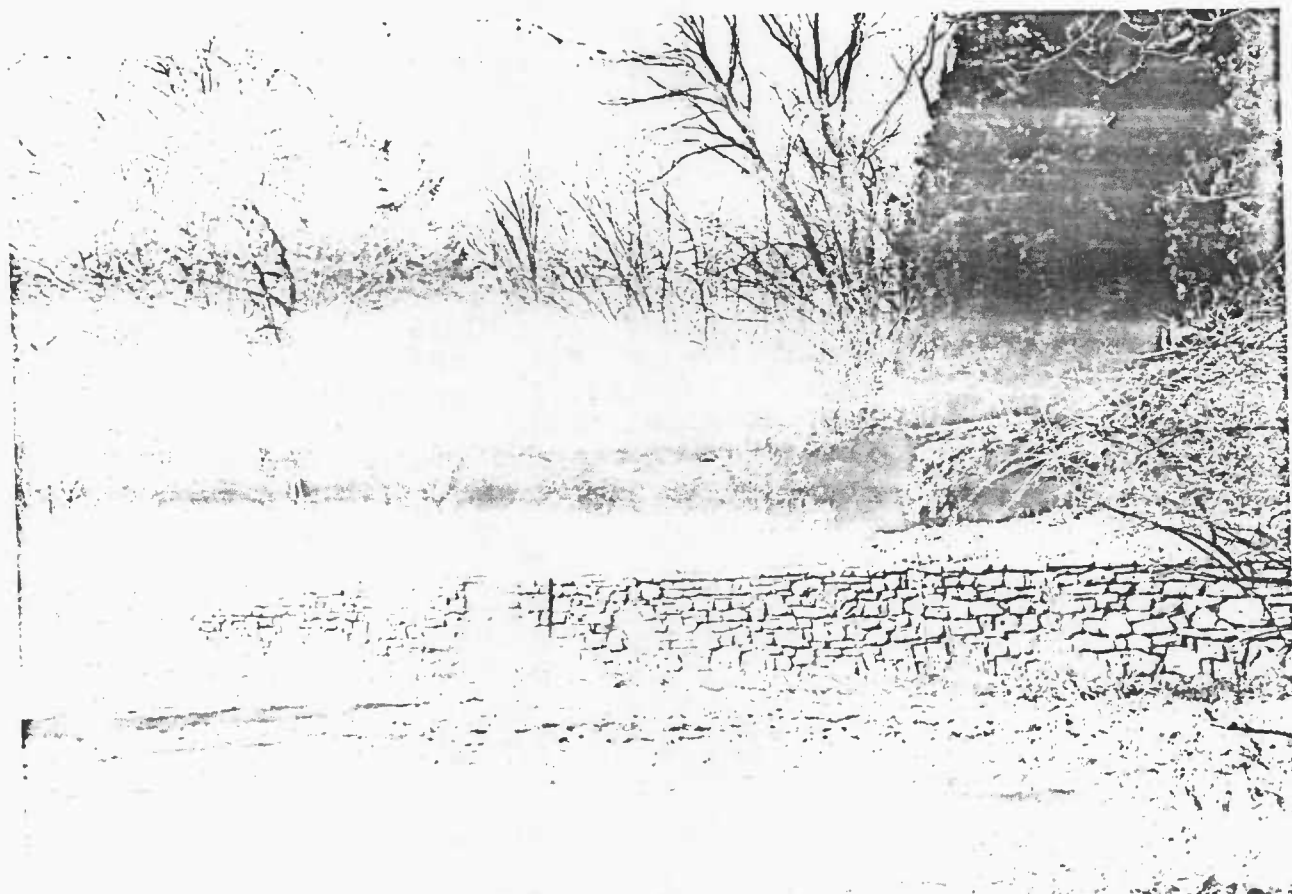
Glenelg Manor HO-15
Howard County, Maryland
Mark R. Edwards, February, 1980
Neg. located at MHT
View of terraces and coursed stone
22 of 24

To the south of the complex of Glenelg School is an elaborate network of terraced gardens, the outlines of which are created by random coursed fieldstone walls, allees of boxwood interspersed with grouped plantings of cedar trees. Other ornamental trees such as red maples and the necessary outbuildings are incorporated at various points for contrasting interest. This landscaping provides a variety of picturesque vistas which, as the visitor wanders, in turn frame both house and landscape.
